SoC 101:

Lecture 8: Ramp up and Debug a.k.a. “Lupulus: A Debug Story”

Prof. Adam Teman

EnICS Labs, Bar-Ilan University

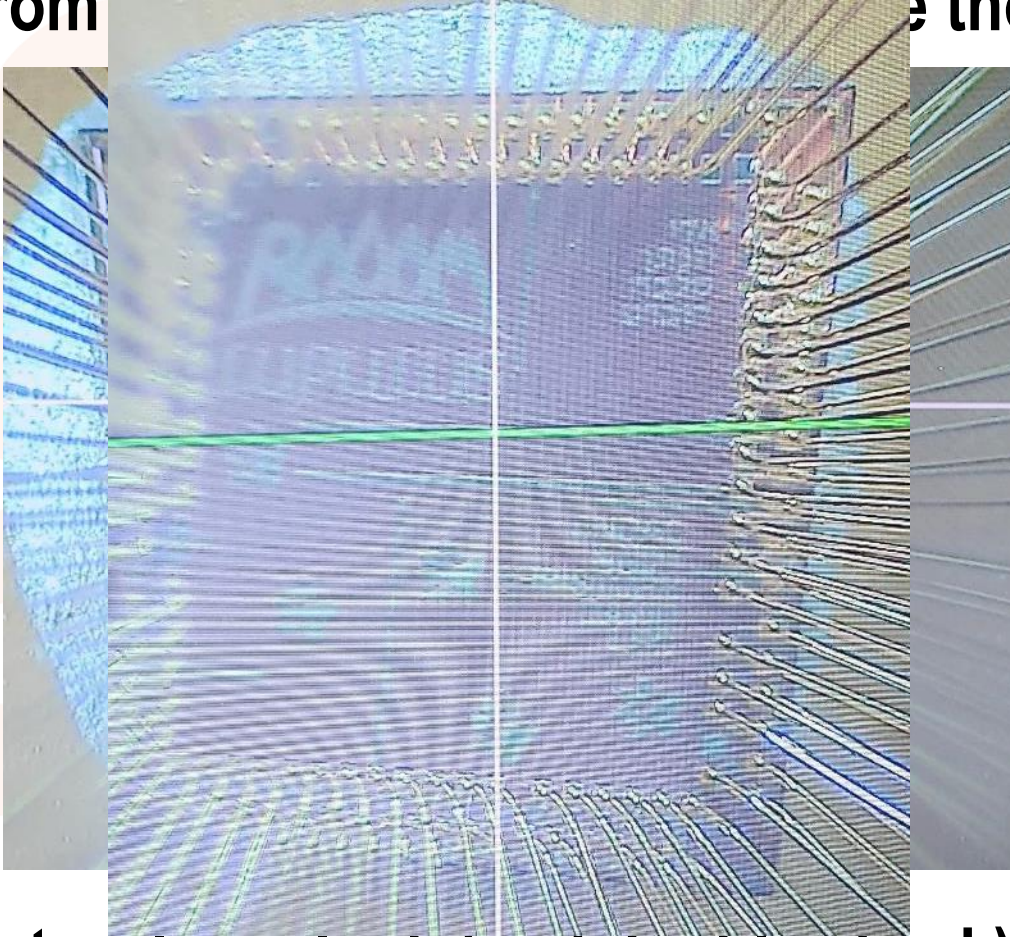
- From our first look at the chip we thought it was **rotated**

- But a closer look (and double check) showed that **the orientation was correct.**

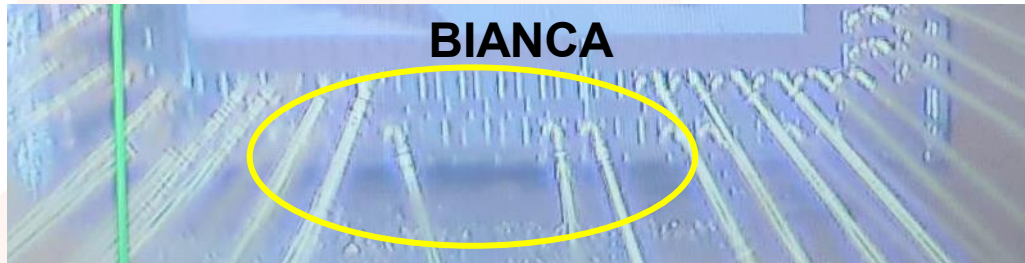
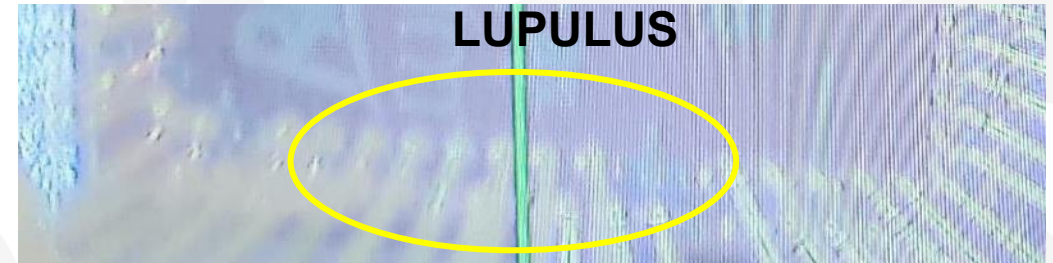
- Something was *very strange* on the bottom edge...

- It looked a little fishy...
- So we dug deeper...
 - Pin 57 isn't connected!

- What is it?
 - ...the clock!

- Not connecting the clock is a good reason for nothing to work...
 - Basically, removing the chip from the socket gave the exact same response...
- We all breathed a sigh of relief and got ready for measurements.
- A quick fix at the bond house and everything will be good.

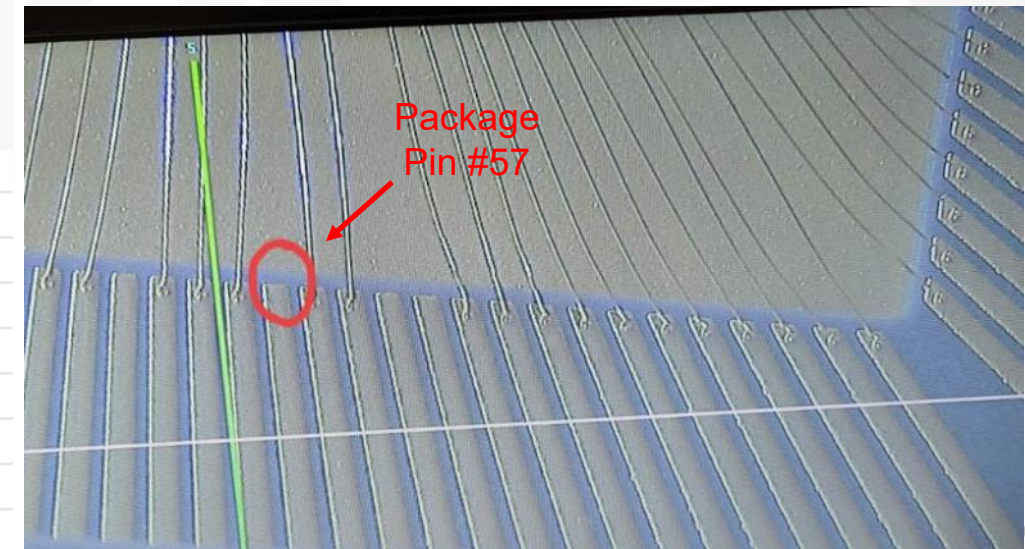
47	PAD_AQUA_IN_3	47	Q5
48	PAD_AQUA_IN_4	48	P7
49	PAD_EXT_40M_CLK	57	Q10
50	PAD_JTAG_TMS	50	Q6
51	PAD_JTAG_TDO	51	Q7
52	PAD_JTAG_TCK	52	P8
53	VDDIO		
54	VSS	54	N8
55	PAD_JTAG_TRSTN	55	N9

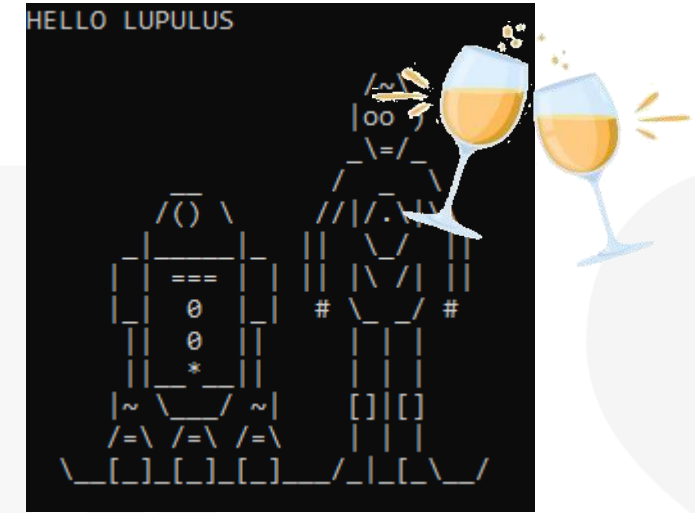
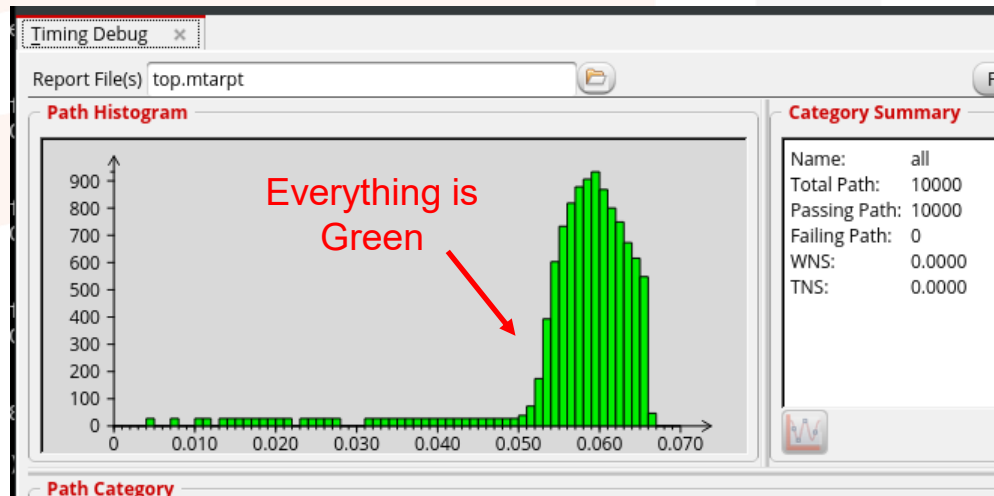
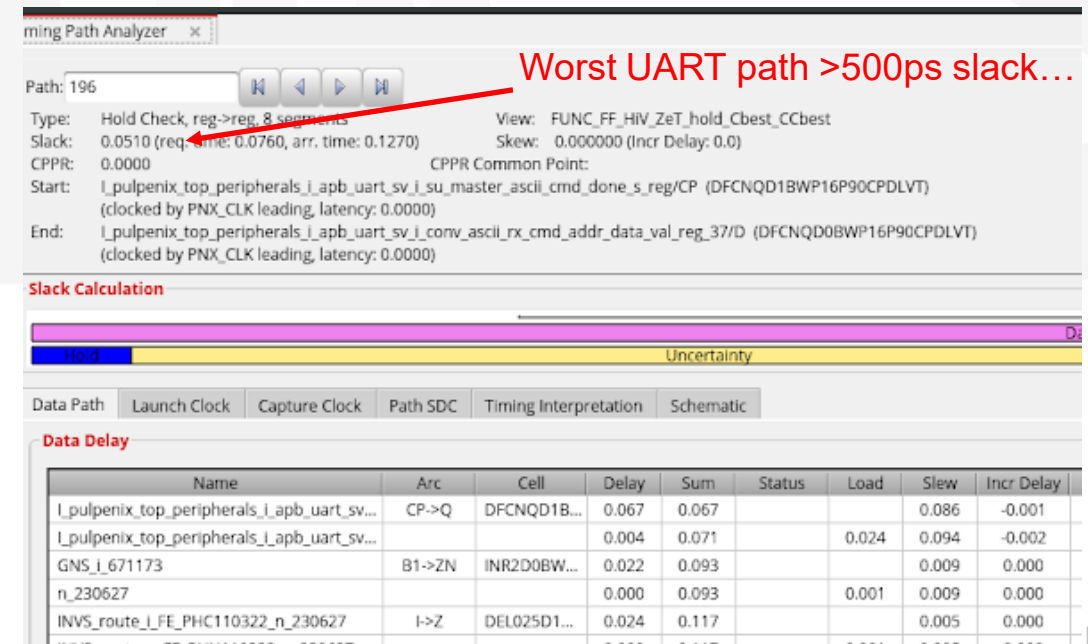
- Let's further reduce the voltage...
 - More addresses start to work.
- Even more...
 - At 0.67V we get a "Hello, World!"
- But it can't be...
we checked hold before tapeout...

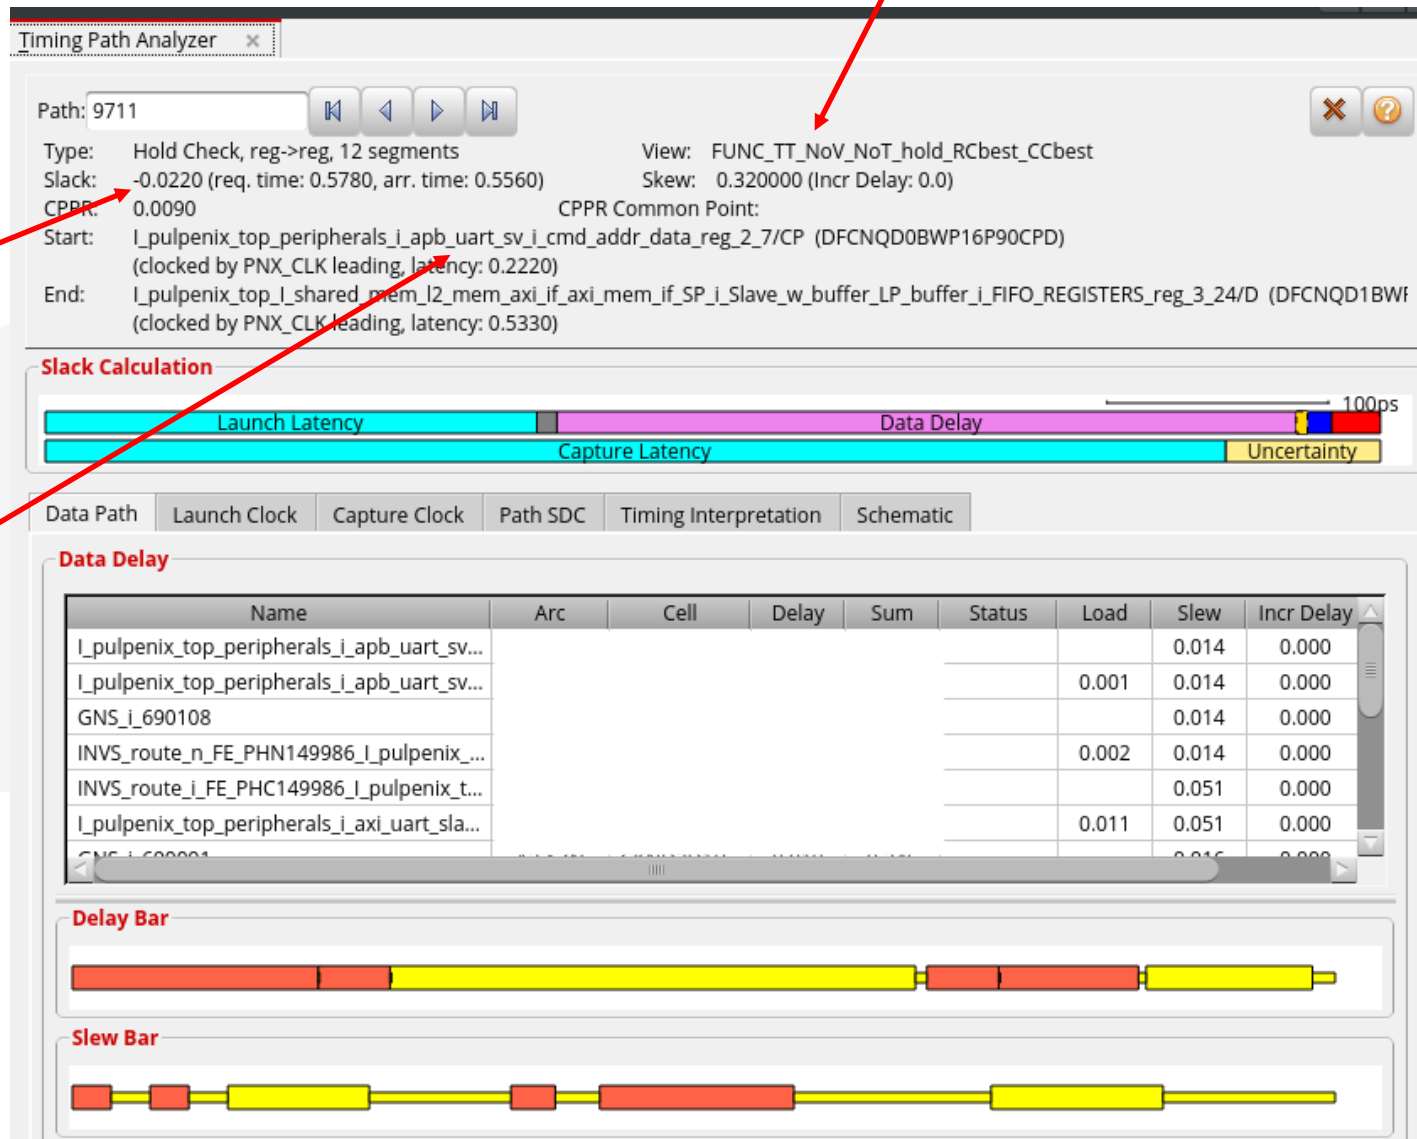
TT Corner

-22ps
negative
slack

A path through
the UART

- So, yes... **hold is real...**

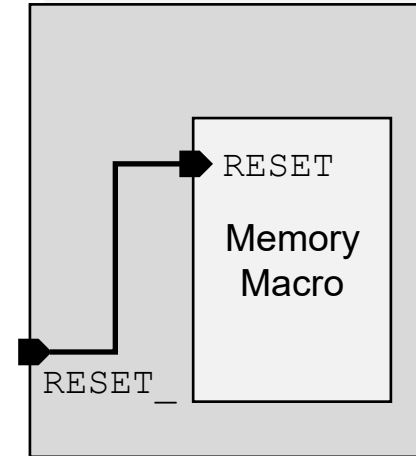
- After a few days of searching for a needle in a haystack we found the problem.
- The memory macro has a **RESET** input
 - This disconnects the sense amplifiers and outputs a constant '1'...
- But the SoC has a **RESET_** signal
 - So, the minute the SoC **releases reset**, the macro **is reset**...
- How did this happen?
 - Another *potential point of failure* – the **Behavioral Model**.
 - Logic simulations are run with a **Verilog model** of the IP that is written by hand.
 - The behavioral model was **not equivalent** to the analog IP.
- **Solution**
 - Always run (at least basic) **mixed-signal verification!**
