SoC 101:

Lecture 8: Ramp up and Debug a.k.a. “Lupulus: A Debug Story”

Prof. Adam Teman

EnICS Labs, Bar-Ilan University

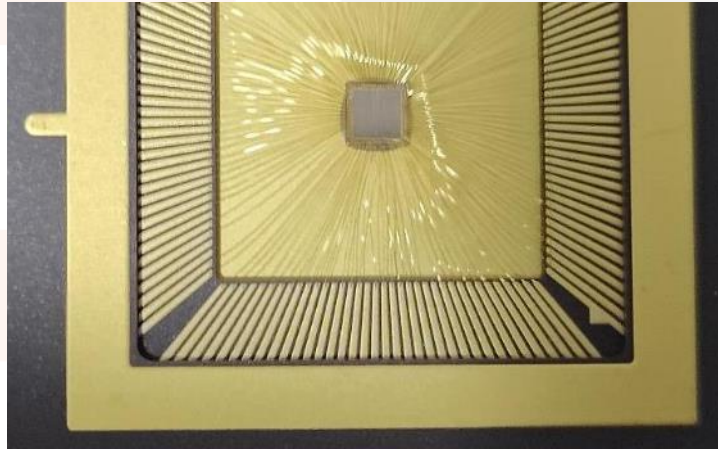
• Not so fast!

- We got the **exact same response** from the chip!
